ROCKBURSTS IN ONTARIO MINES DURING 1984

D.G.F. HEDLEY AND
R.J. WETMILLER

July 1985

SP85-5

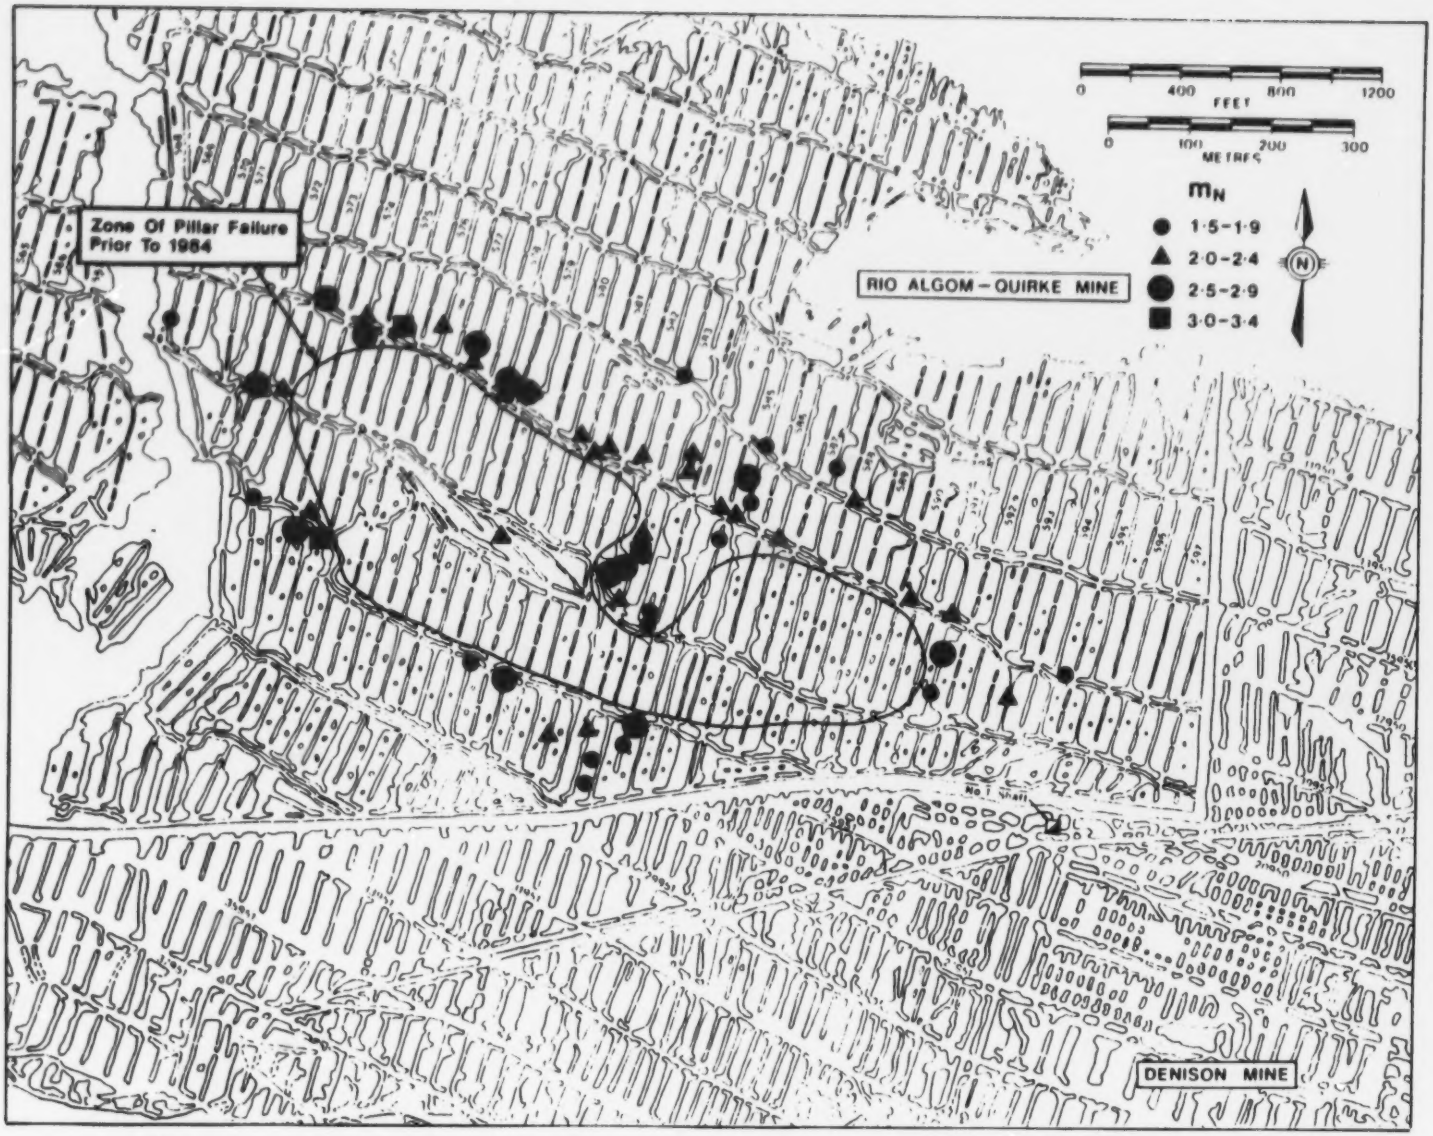
***Fig. 5** -- Partial plan of Quirke and Denison Mines showing rockburst locations*

Over a five-day period in March 1982, eight major rockbursts up to a magnitude of 3.0 were recorded on the regional seismic network. Afterwards, seismic activity continued and spread outwards. In August 1982, a 16-channel microseismic network was installed around the affected area which was enlarged to 32 channels in 1983, with 9 channels being installed on the Denison side of the boundary pillar. At the end of 1983, the area of observed pillar deterioration extended 1200 m on strike by 550 m on dip. Within this area, there was a zone of complete pillar failure (see Fig. 5).

1984, seismic activity was averaging 11 events per day. As listed in Table 1, major rockbursts again started on September 6, 1984, and 24 were recorded during September by the regional seismic network, up to 3.0 M_N. The locations of these and subsequent rockbursts are shown in Fig. 5. The September rockbursts were located around the periphery of the zone of pillar failure, centred on the trial trackless area. Activity on the microseismic network averaged 104 events per day during September, and reached a maximum of 250 events per day. Also in September, an isolated rockburst occurred in the adjacent Denison Mine about 1300 m from the nearest rockburst in Quirke Mine.

As can be seen in Fig. 5, all of the major rockbursts in 1984 except one are located outside the estimated zone of pillar failure prior to 1984. It is considered that these rockbursts are located in the orebody and result from the violent failure of the pillars. The sudden change in potential energy as the hanging wall moves down is thought to be the major source of the liberated seismic energy. The rockburst on December 22, 1984, is located in the centre of the trial trackless area. From visual observations in July 1982, it is known that the pillars in this area are extensively crushed, and that their peak strength has been exceeded. Based on this observation, it is concluded that this rockburst probably occurred in the hanging wall. A mud-coated thrust fault is located 36 m above the orebody at this location, and slippage could have occurred along this fault. The geophones in the microseismic network are almost in a planar array which makes vertical resolution of rockbursts difficult.

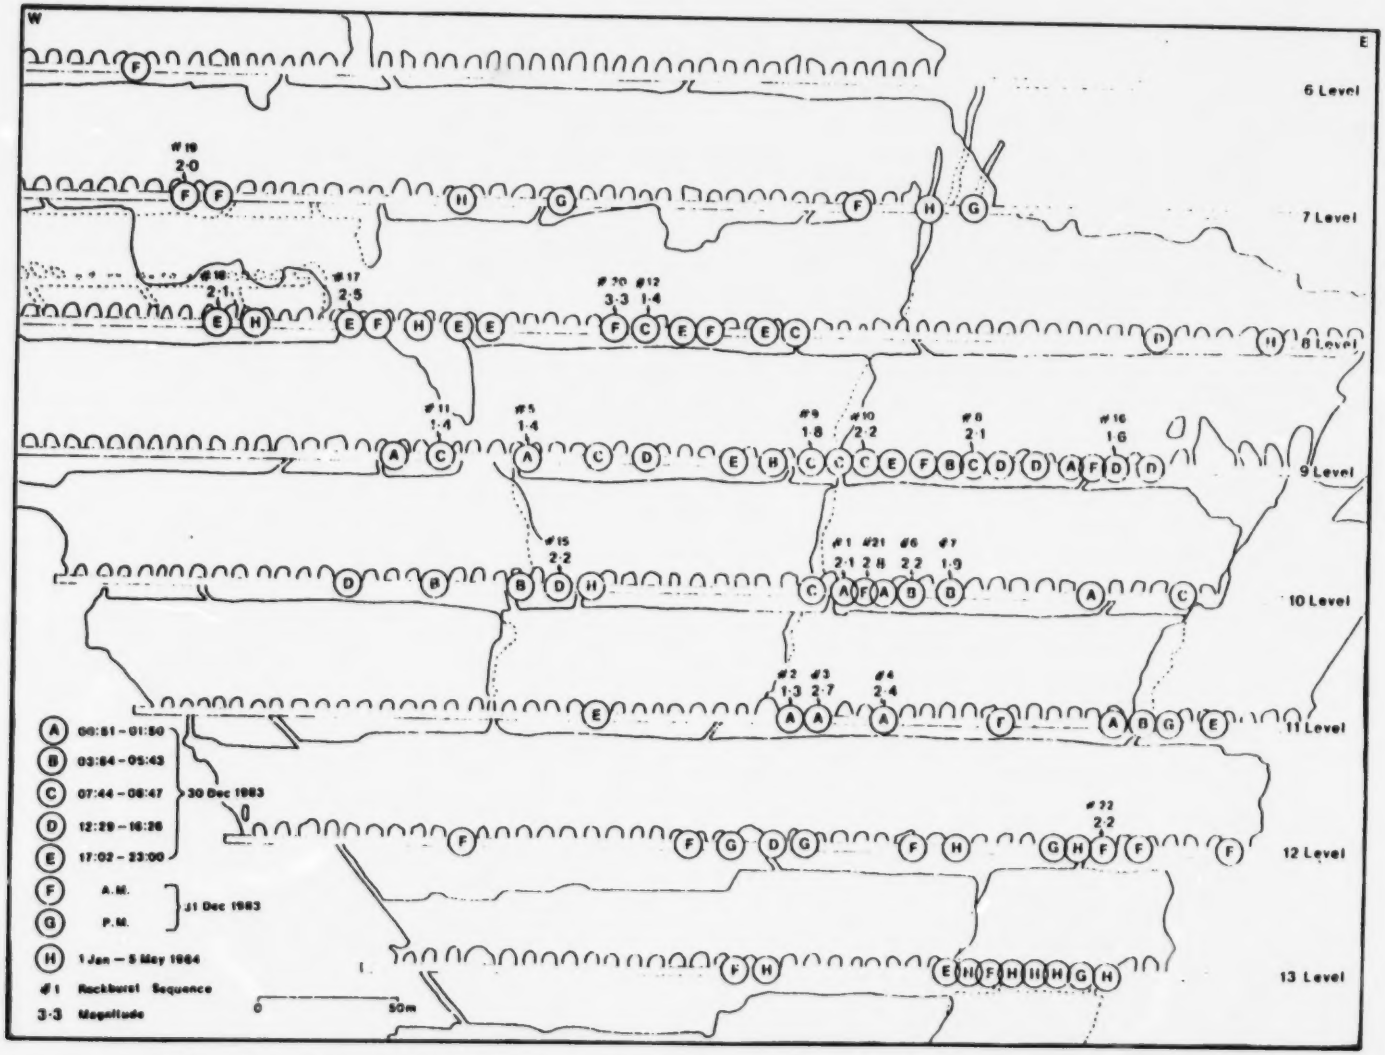
Fig. 6 -- Longitudinal section of F Zone; Campbell Mine showing rockburst locations

of the rockbursts (see Fig. 6) closely matches the visible evidence of damage underground (i.e., 7th to 12th levels completely closed off). The vast majority of major seismic events occurred where the sill pillars are 6 m wide (on dip); very few events occurred where the sills are 15 m wide. Another common feature is that the first rockburst on a level often was located where a raise comes through the sill pillar. After January 1, 1984, seismic activity decreased drastically, and there have been only sporadic events in the F zone since that time.

From visual observations, all the rockbursts occurred within the orebody and were the result of violent failure of some of the sill pillars (rather than boxhole pillars). The major driving force appears to be the change in potential energy as the hanging wall and footwall suddenly converge.

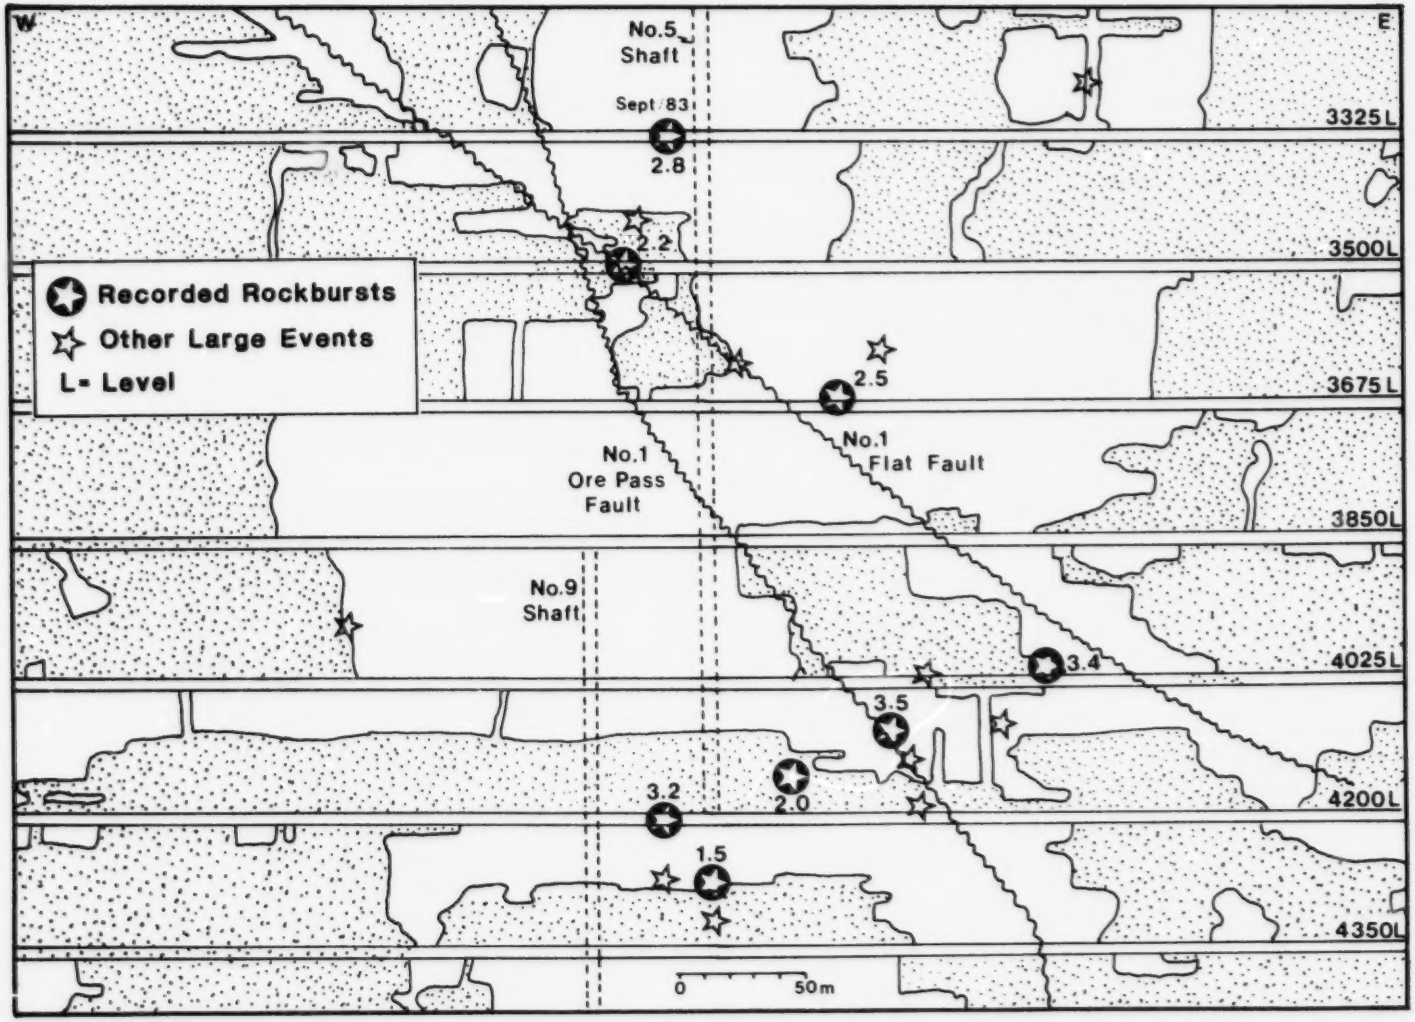
***Fig. 7** -- Longitudinal section of Falconbridge Mine showing rockburst locations*

The first rockburst of magnitude 3.4 M_N occurred, without apparent warning, on the No. 1 flat fault on the 4025 level. Unfortunately, this was about 20 m from where four miners were working in an undercut-and-fill stope. Shock waves from this rockburst caused the overlying mat to collapse entrapping the miners in backfill. Two hours later, the next major rockburst, 3.5 M_N, occurred on the No. 1 ore pass fault between the 4025 and 4200 levels followed eight minutes later by a 3.3 M_N event on the same fault and on the 4200 level. For the rest of June 20-21, seismic activity was mainly restricted between the 4025

Visual inspection of the mine workings indicated damage between the 4025 to 4375 levels with about 1000 - 2000 tonnes of rock displaced. This is much less than that observed at Quirke Mine in Elliot Lake or Campbell Mine at Red Lake for pillar bursts of similar magnitude. Slight damage, such as extension of fresh cracks, was observed over a circular area of radius 150 m centred on the 3.5 M_N event.

The location of the rockbursts from the microseismic system plus the visual observations, point to a fault-slip failure mechanism. This was visually confirmed for the 2.2 M_N rockburst on July 5 where there was no observed damage, and from striation marks on the No. 1 flat fault on the 3500 and 3675 levels, the west block had moved laterally 1 - 2 cm towards the orebody.

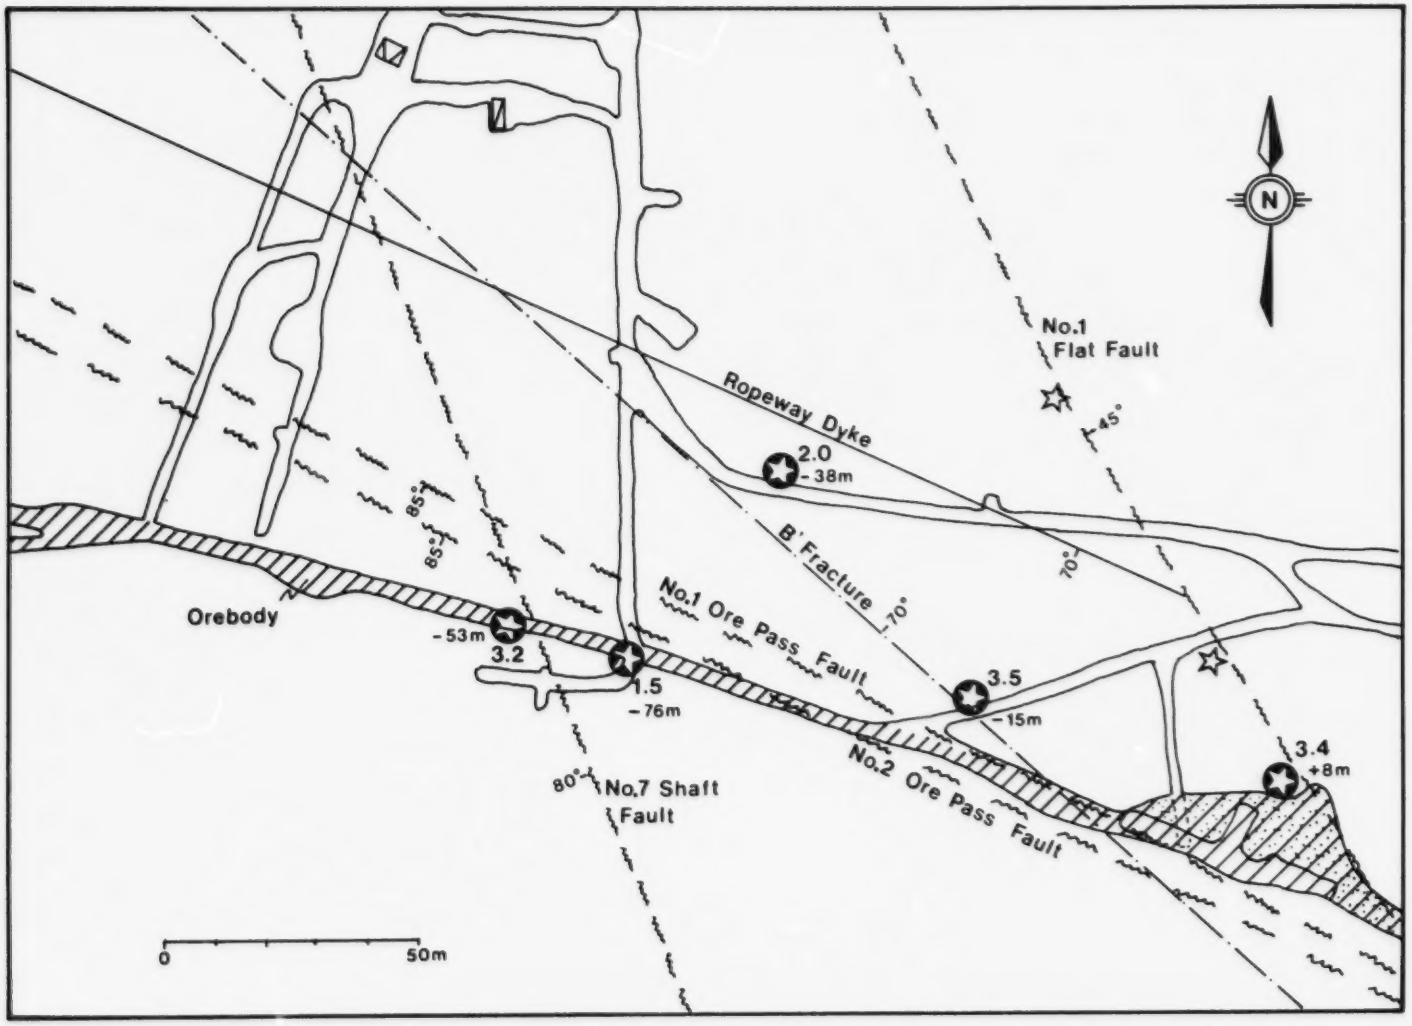
Fig. 8 *-- Plan of 4025 level, Falconbridge Mine, showing faulting and rockburst locations*

At 1012 on June 20, 1984, the first of a series of major rockbursts occurred and, over a 24-h period, about 250 seismic events were picked up by the microseismic system. A case history of these rockbursts has been written (West, 1985). The seven rockbursts over a magnitude 1.5 M_N recorded on the regional seismic network are listed (see Table 3), and their locations are shown plotted on a longitudinal section in Fig. 7. Those rockbursts near the 4025 level are plotted on this level plan in Fig. 8 which also shows the location of the major faults.

and 4350 levels and over a distance of 200 m on strike; a relatively small area (see Fig. 7). Most of this activity appeared to be associated with the No. 1 flat fault, the No. 1 and 2 ore pass faults, and the Ropeway dyke. During June 23, seismic activity moved up dip and one rockburst, 2.5 M_N, occurred on the 3675 level again on the No. 1 ore pass fault. The last major rockburst, 2.2 M_N, occurred on July 5 on the 3500 level and on the No. 1 flat fault.

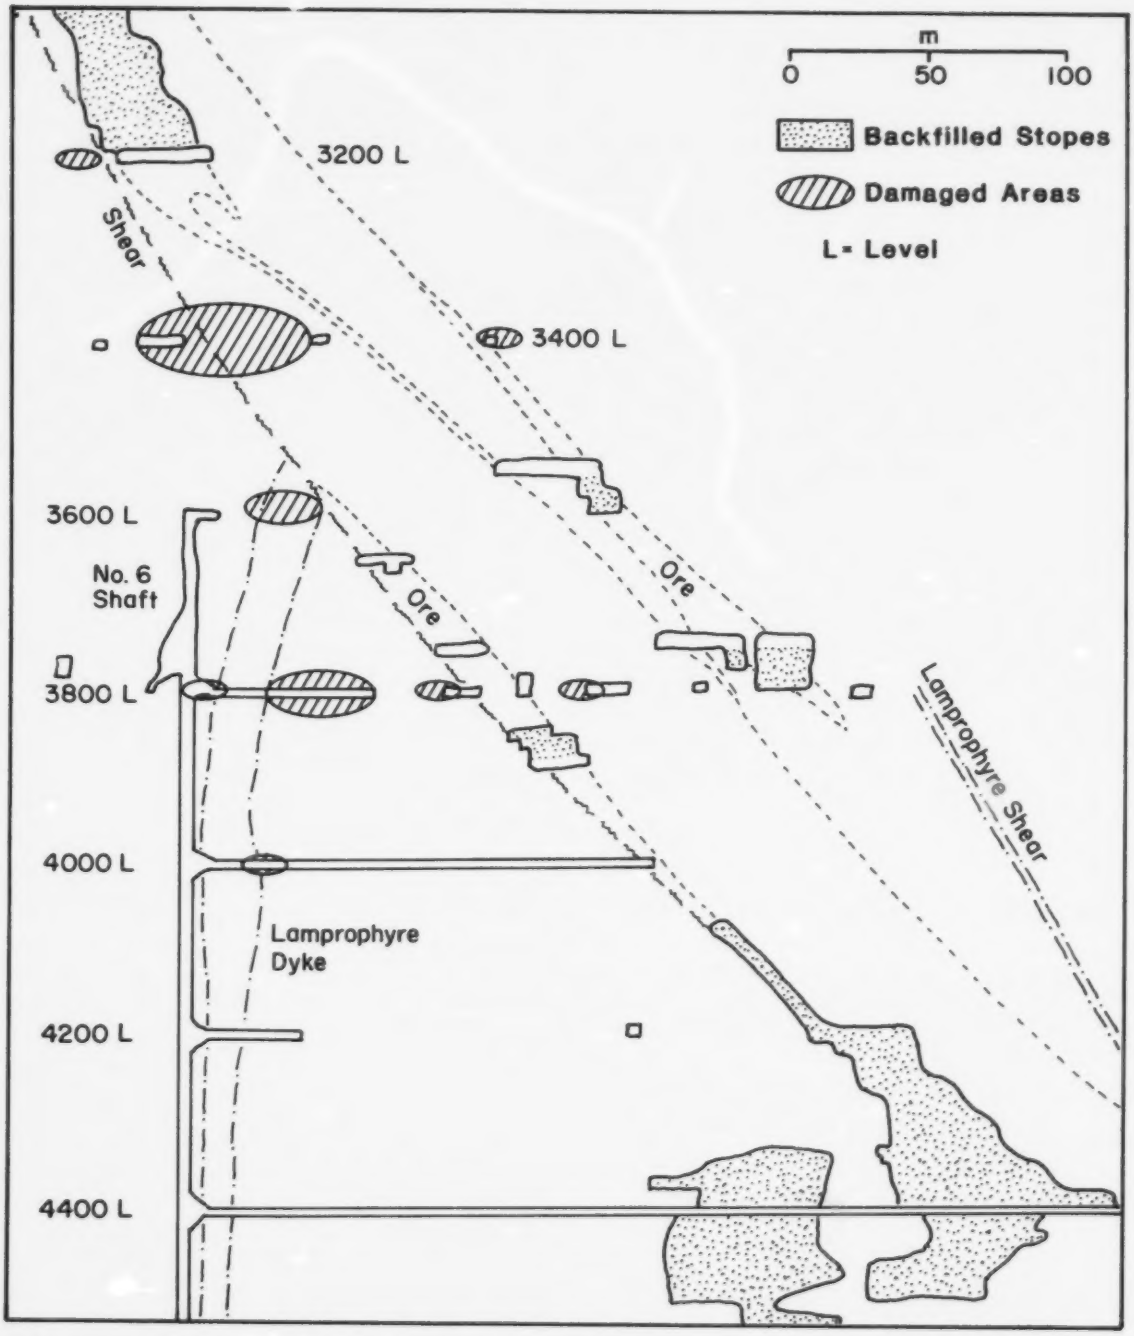
***Fig. 9** -- Creighton Mine, transverse section through No. 6 shaft showing damaged areas (projected)*

Visual inspection of the mine workings took place on July 7, and damage was found on the 3200, 3400, 3600, 3800, and 4000 levels (975 - 1220 m depth) with most damage on the middle three levels. A transverse section, through No. 6 shaft, is shown in Fig. 9 on which the areas of damage have been projected. An additional damaged area was found near No. 5 shaft on the 3400 level where a quartz diorite dyke intersects the development drift and some 250 m away from the other damaged areas. About 1000 tonnes of displaced rock was observed in the access drifts with little or no damage in either the cut-and-fill or undercut-and-fill stopes in this area. Quite a few damaged areas were adjacent to the quartz diorite and lamprophyre dykes. This level of damage is consistent with strain energy type of bursts of 1.5 - 2.5 M_N. No evidence could be found of the first 4.0 M_N event.

Although the microseismic system recorded the events, the nearest geophone was about 1000 m away from the damaged areas. Also, all the geophones lay within a narrow cone configuration relative to the damaged areas making accurate source location difficult. However, it was possible to obtain approximate locations by evaluating the sequence of geophone triggering. For the first rockburst, 4.0 M_N, the best location is a few hundred metres into the hanging wall and between the 3400 and 4000 levels. All subsequent rockbursts (1.5 - 2.5 M_N) were located in the footwall, presumably at the locations where damage was observed. The most likely mechanism of the first rockburst is sheer-slippage either along a dyke contact or on the western edge of a subsidence zone above the 4400 level stopes. This changed the stress regime in the area, which resulted in the subsequent strain energy bursts in the footwall.

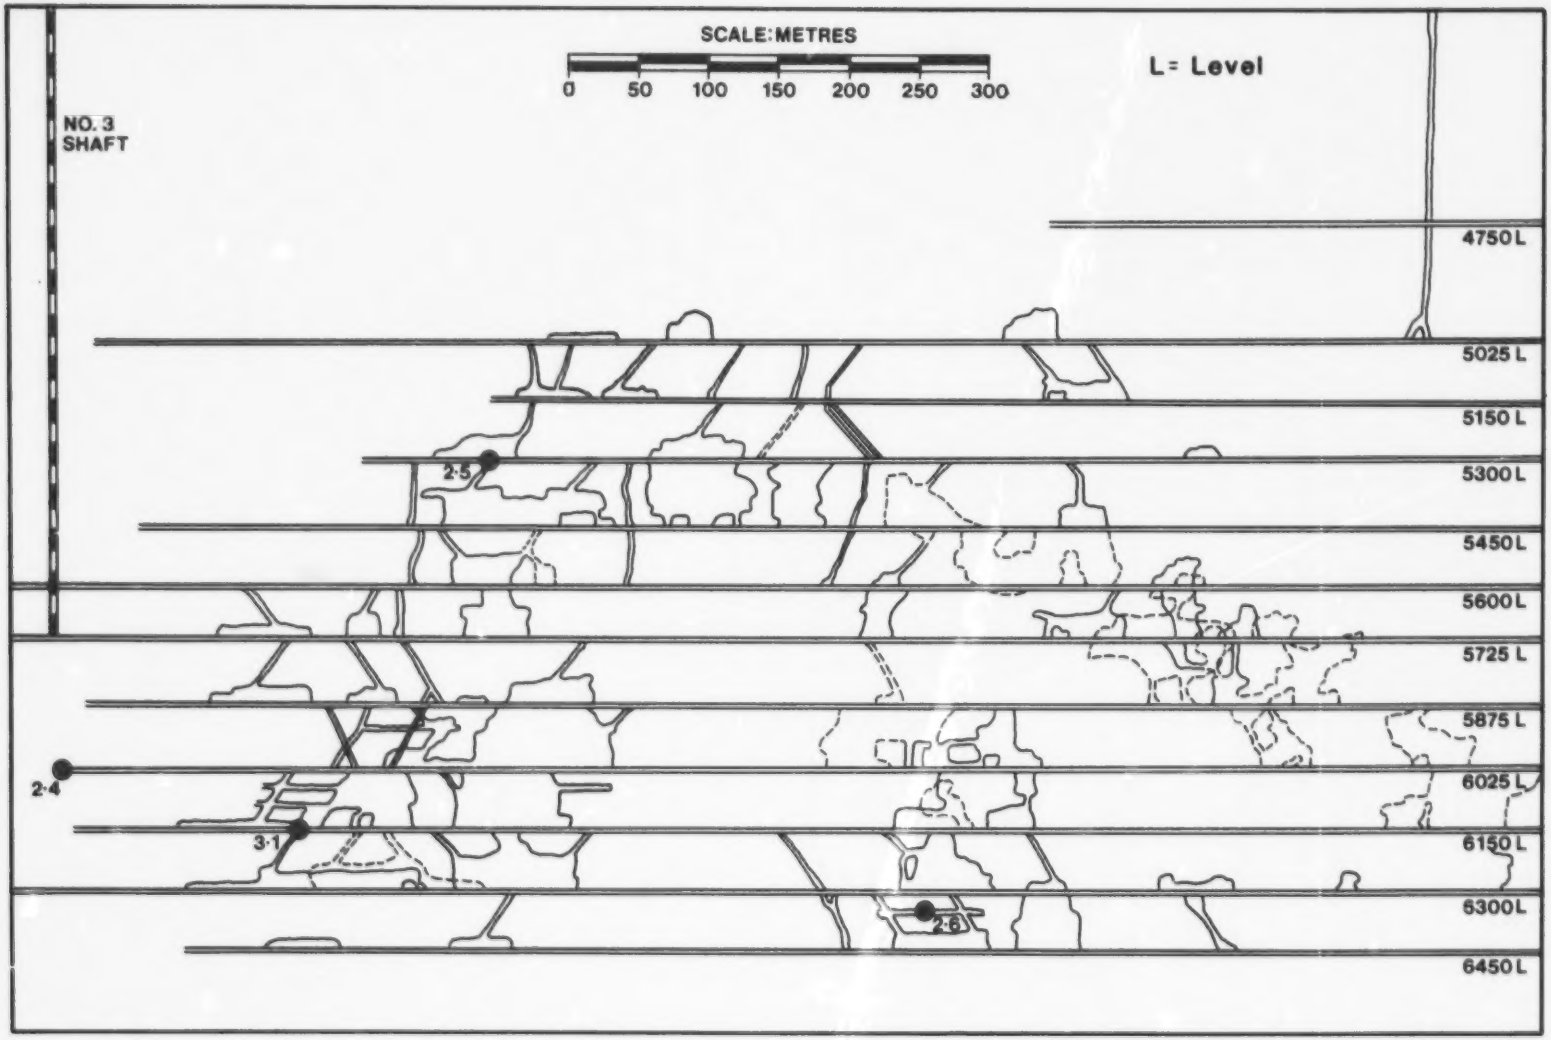
Fig. 10 *-- Longitudinal section of Macassa Mine showing rockburst locations*

Macassa Mine does not have a microseismic monitoring system, and rockbursts are reported by the work crews with visual inspection to determine source location. During 1984, five rockbursts were recorded on the national seismic network (see Table 4). Locations of the centres of most damage for four of these rockbursts are shown on a longitudinal section (Fig. 10). The three largest rockbursts of magnitudes 2.5, 2.6, and 3.1 M_N all appear to have occurred in the sill pillars and within the orebody. Most damage was observed in the levels and sub-levels and up to 130 m of the 6150 level was closed after the 3.1 M_N event. The 2.4 M_N event on the 6025 level appears to be a strain burst because it occurred in an isolated development drift. Similarly, the 2.2 M_N event on the 4600 level, in the central area of the mine, was also in an access drift with no noticeable damage to the adjacent stopes.

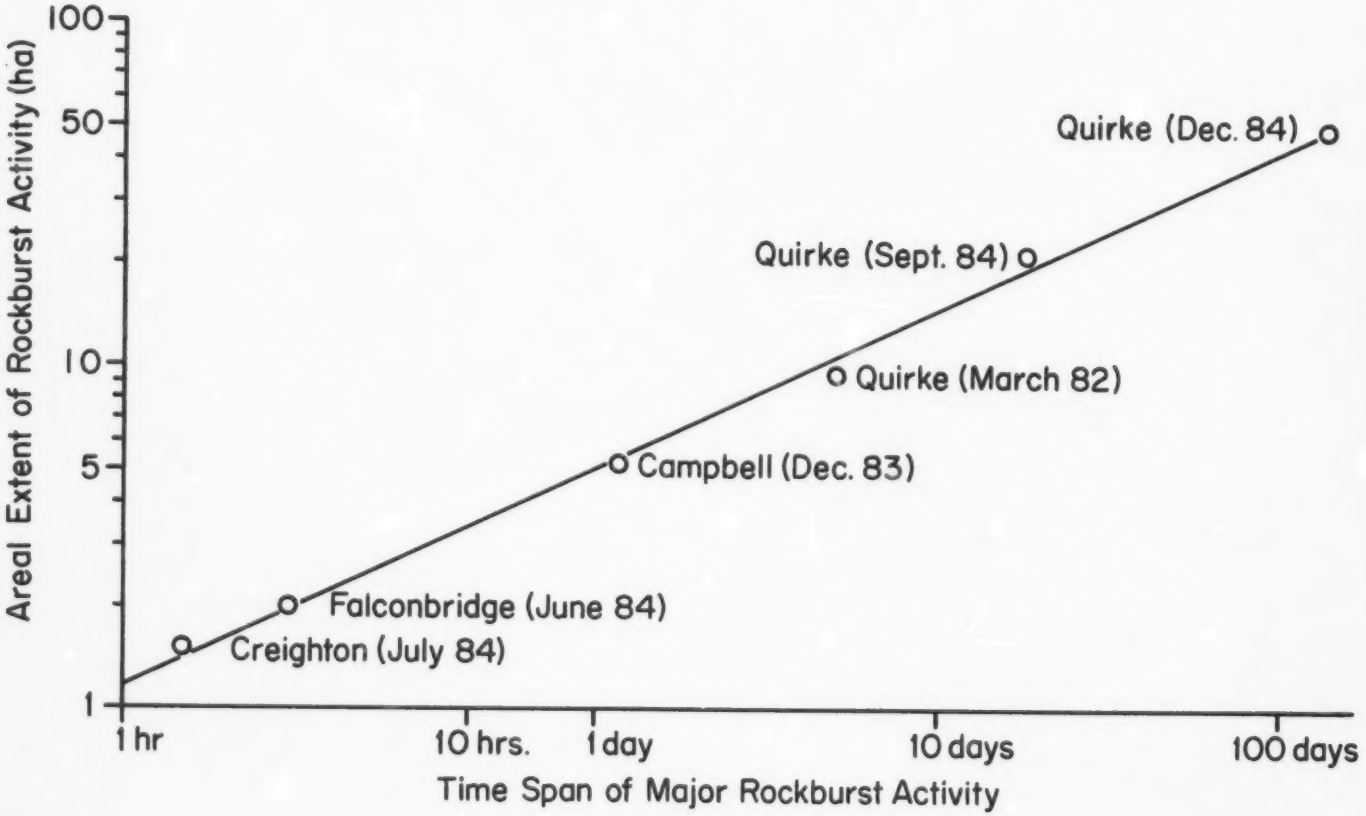
Fig. 11 -- *Relationship between areal extent and time span of major rockburst activity*

The time span over which major rockbursts occur ranges from 90 min at Creighton Mine to 134 days (December 17, 1984, to April 30, 1985) at Quirke Mine. Although this time span can be affected by the type of rockbursts, mining methods, and support (i.e., backfill) there appears to be a reasonable correlation with the areal extent of rockburst activity (as shown in Fig. 11). Although the end of a major rockburst sequence is somewhat arbitrary because small seismic activity continues and a real rather than volume extent is used, a log-log relationship adequately fits the data from all four mines. This type of relationship requires further scrutiny of its implications on rates of energy released and rockburst propagation.
